# REPORT 1363

## ORIGIN AND PREVENTION OF CRASH FIRES IN TURBOJET AIRCRAFT<sup>1</sup>

By I. IRVING PINKEL, SOLOMON WEISS, G. MERRITT PRESTON, and GERARD J. PESMAN

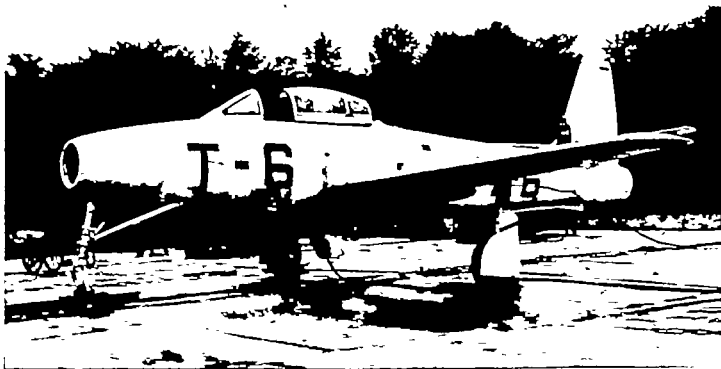
The F-84 fighter (fig. 3), carrying its turbojet submerged in the fuselage structure, caught fire in a similar crash. In this crash the fuel that entered the engine inlet was spilled from a fuselage tank adjacent to the engine-inlet duct. Arrangements for ensuring the failure of this tank in the crash are shown in figure 4. A driving strut was attached at one end to the nose wheel strut. The free end of the driving strut carried a spear-like tank cutter aimed at the fuselage fuel tank, whose wall is adjacent to that of the air duct. When the nose wheel strut failed rearward in crash, the driving strut cut the duct and tank walls. Fuel in liquid form poured into the air duct and was drawn into the engine.

FIGURE 3.—F-84 Fighter airplane used in crash-fire investigation.

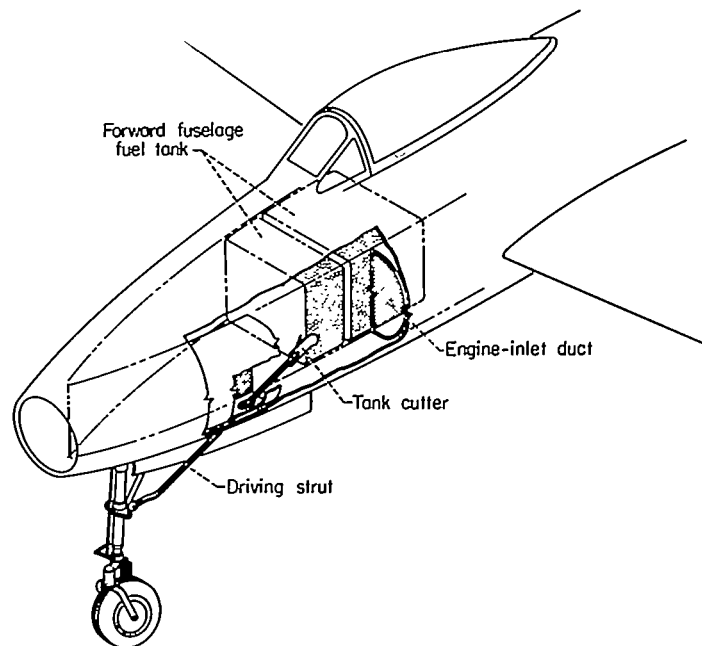
FIGURE 4.—Schematic diagram of F-84 tank-cutting mechanism.

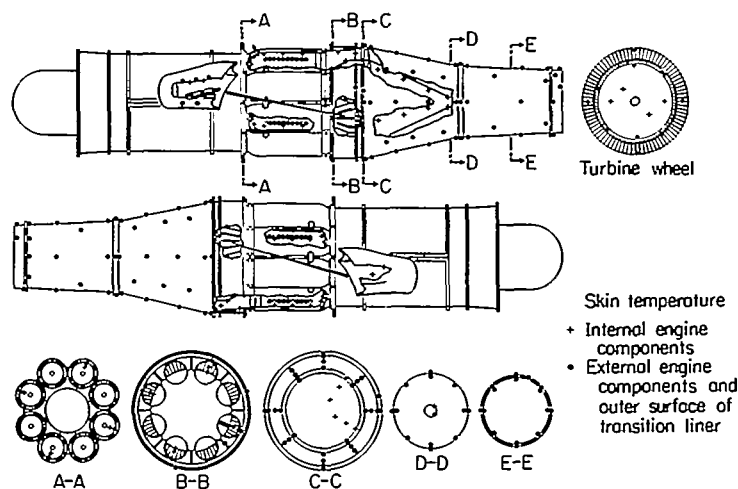
**Hot-metal surfaces.**—If combustor fuel shutoff is provided upon crash and residual flames are avoided, the hot engine metal may be a potential ignitor. Consequently, the temperatures of characteristic engine parts downstream of the compressor were measured on test-stand engines at locations shown in figure 6 for a period following combustor fuel shutoff. Thermocouples reading temperatures on rotating engine

FIGURE 6.—Thermocouple locations on J47 engine.

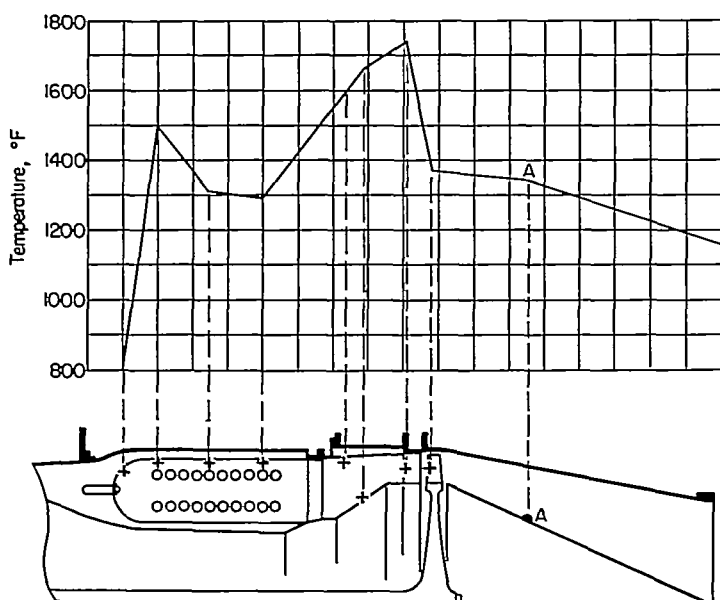
Maximum temperatures obtained with the J47 and J35 engines running on the test stand were comparable (fig. 7). Temperatures of similar locations in the J30 engine, which are not given here, were also comparable to those recorded on the J47 and J35 engines.

FIGURE 7.—Maximum temperatures of metal components in main gas stream of J47 and J35 engines.

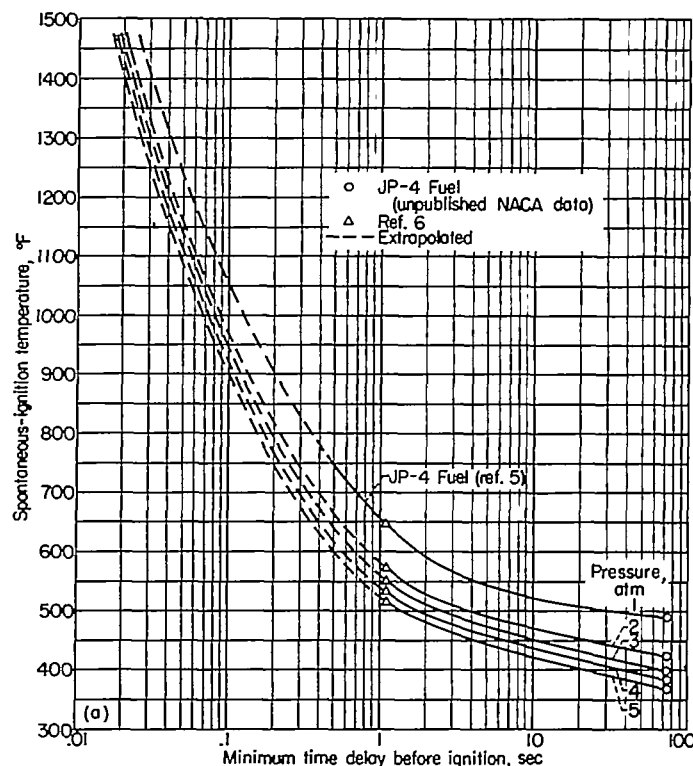
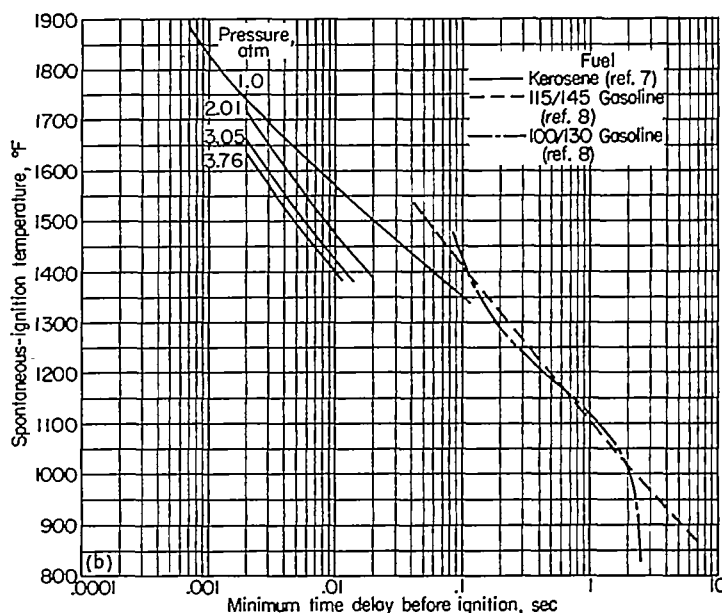
The relation between surface temperature and contact time required for ignition is shown by data given in figure 8(a) for JP-4 fuel (refs. 5 and 6 and unpublished NACA data). Two main trends are evident. (1) The required contact time decreases with increasing surface temperature. (2) When the combustible atmosphere is at high pressure, which exists within an engine during the initial stages of a crash, ignition is possible at a lower surface temperature for a given contact time. As the pressure decreases to atmos-

The corresponding curves for kerosene and 115/145 and 100/130 aviation gasolines (refs. 7 and 8) show the same trends as the curves for JP-4 fuel (fig. 8(b)). The fact that a contact time of more than 0.1 second is required to ignite a combustible atmosphere of JP-4 fuel on a 1000° F surface and a combustible atmosphere of gasoline on a 1400° F surface is important in the problem being investigated herein.

FIGURE 8.—Ignition characteristics of aviation fuels.

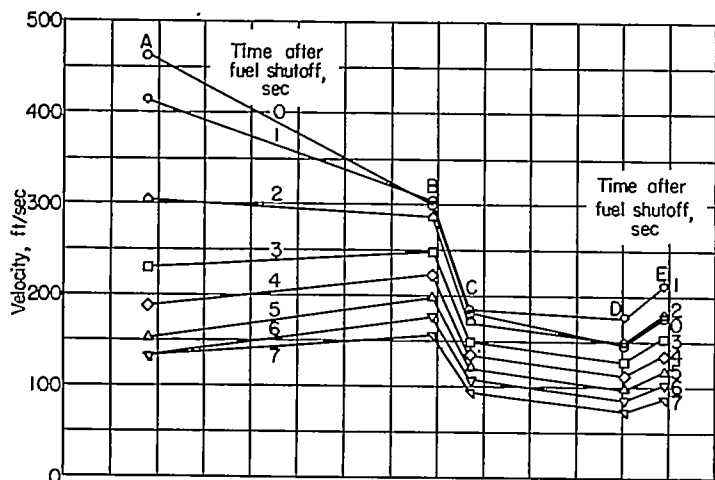
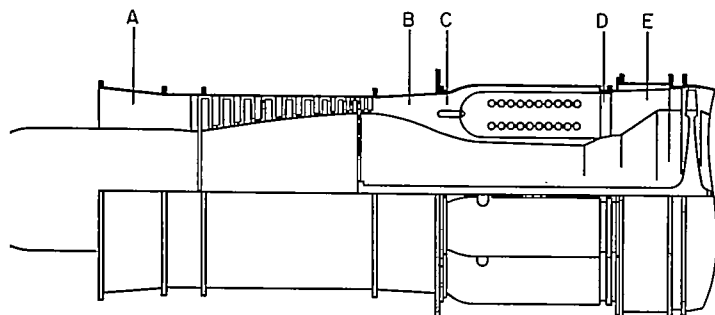
A study of the gas velocity through the hot zones of the engine in the main gas stream showed that combustibles pass through these zones too rapidly to ignite. This is true for approximately 20 seconds following engine combustor fuel shutoff. After this period, the probability of fuel ingestion is quite low. The engine temperature and velocity data used in this study are discussed in appendix B for the J35 engine. In these studies the engine temperature and air velocity data provided in figures 9 and 10 were used. Similar studies which led to the same result were made for the J30 and J47 engines. The method of analysis discussed in appendix B provides a first appraisal of the possibility of ignition of ingested combustibles by components in the main gas stream.

FIGURE 9.—Air velocity through J35 engine after combustor fuel shutoff.

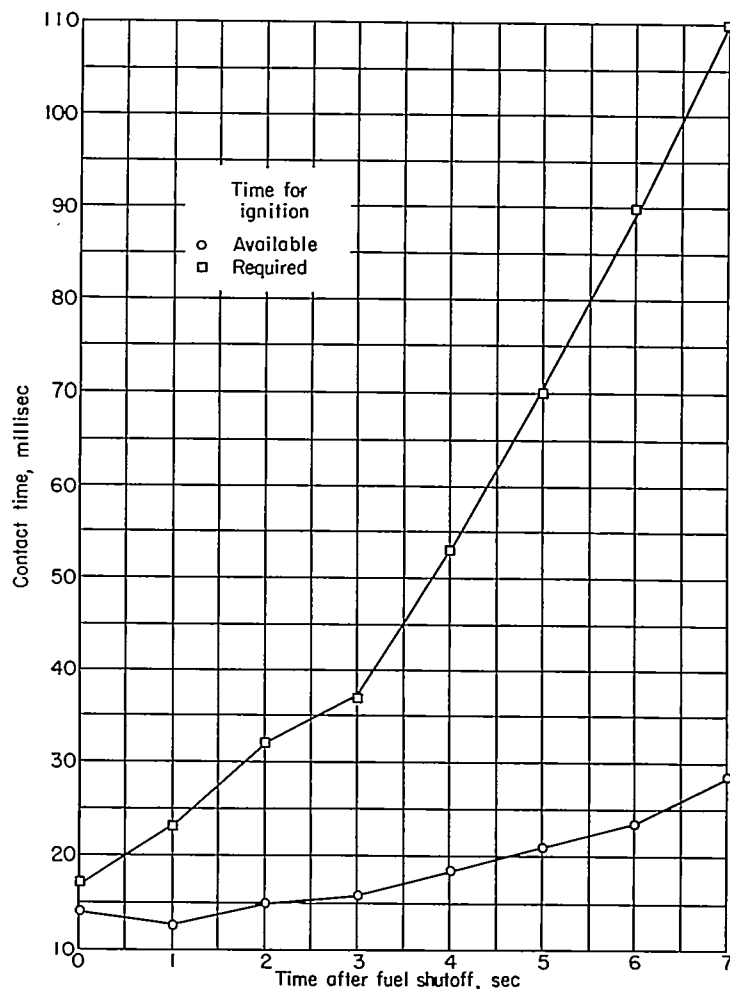
FIGURE 10.—Analysis of ignition probability in J35 combustor.

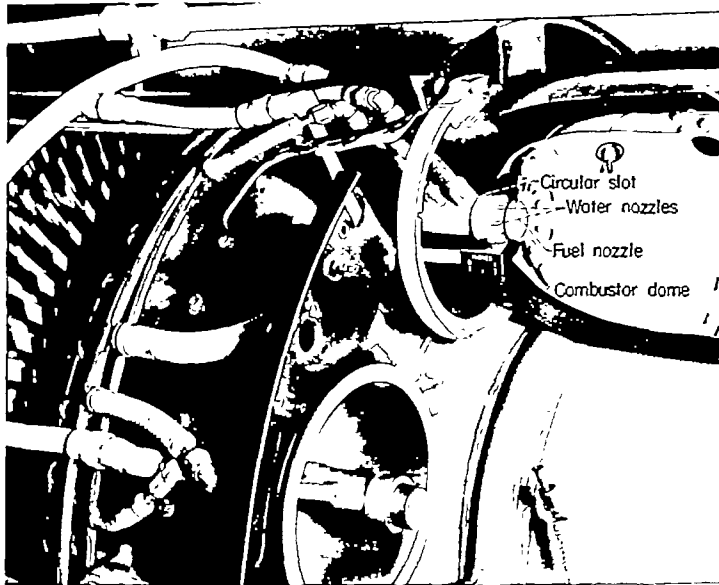
FIGURE 15.—Combustion-chamber water spray nozzle (J47 engine).

water manifold surrounded each fuel nozzle. Eight 0.082-inch holes on the downstream face of the manifold directed water at the combustor dome and its louvers leading into the combustion space. A continuous circumferential slot, 0.020-inch wide, on the perimeter of the manifold provided a sheet of water spreading radially. This water was directed downstream by the airflow to impinge and wash along the outside surfaces of the combustor liner. The 3 gallons of water delivered to the combustors of the J35 and J47 engines were divided equally among the combustors. The water discharge lasted for 3 seconds.

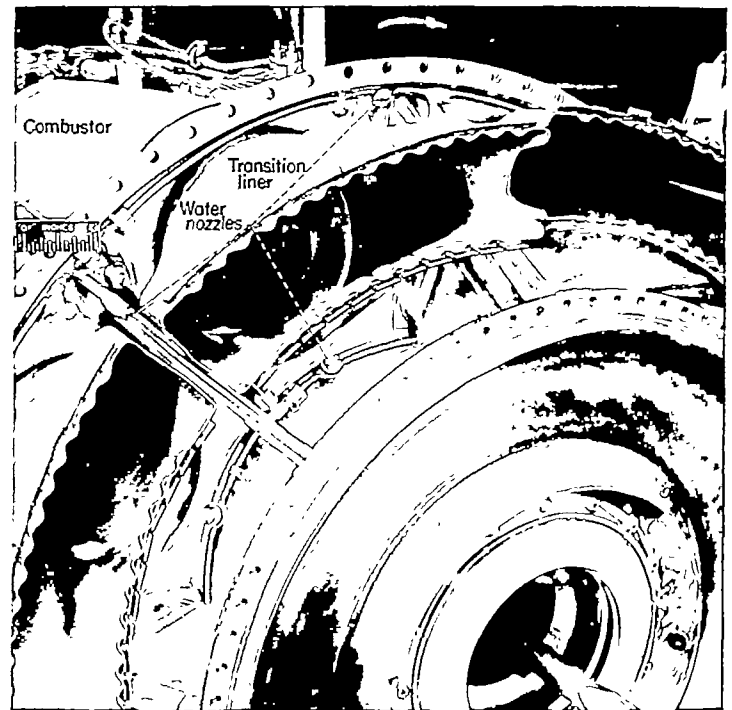
FIGURE 16.—Transition-liner water spray system (J35 and J47 engines).

**Transition liner.**—Water was delivered to each transition liner in a fan-shaped sheet from nozzles arranged as shown in figure 16. Adequate cooling was obtained with three nozzles for each liner by directing the water at glancing incidence to the outside surfaces of the transition liner. One pint of water was discharged onto each transition liner of the J35 and J47 engines.

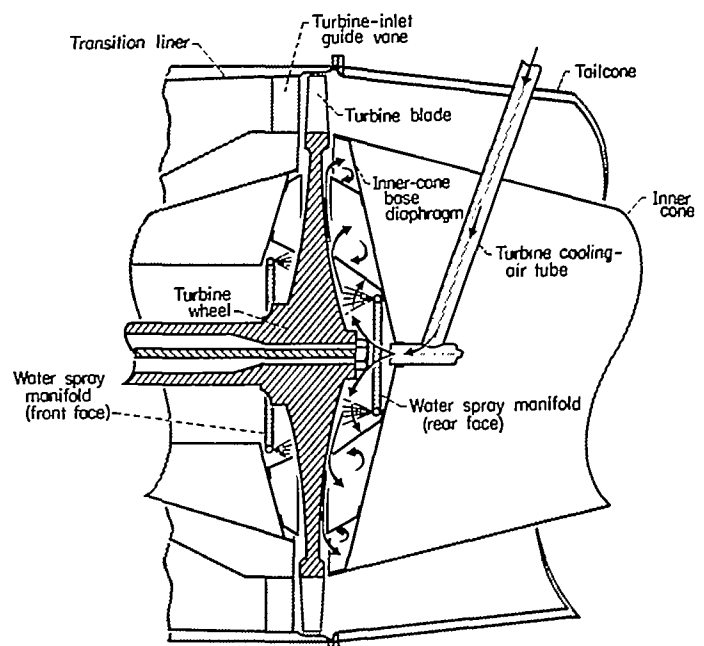
FIGURE 17.—Schematic diagram of turbine-cooling system.

**Turbine.**—Cooling water to the turbine was applied as shown in figure 17. Several streams of water issued from the ring-type water manifold at the hub and spread centrifugally over the rotating wheel. The J35 and J47 engines contained an inner-cone base diaphragm that was hot enough to be dangerous. Cooling was effected by discharg-

ing an additional gallon of water over a 5-second period on the downstream face of the turbine wheel through the turbine cooling-air tube (fig. 17). A portion of this water rebounded from the spinning wheel and sprayed onto the base diaphragm.

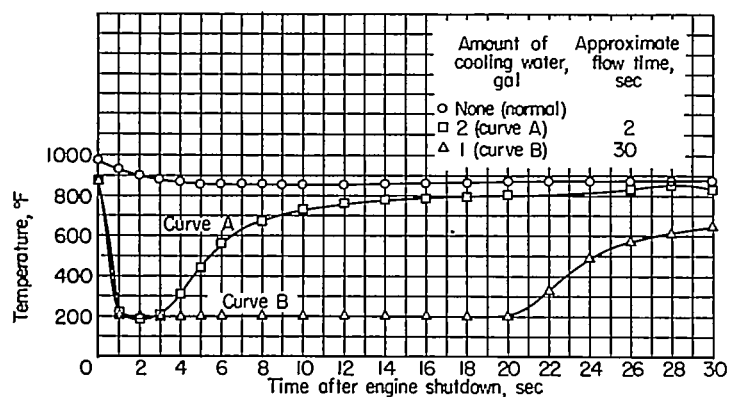
Because the turbine wheel had large mass and thickness, reheating of the wheel surface to unsafe temperatures occurred after the applied cooling water was expended. An example of the reheating of the hottest part of the wheel is shown in figure 18. In early experiments, when 2 gallons of water were sprayed over a 2-second period onto the aft

FIGURE 18.—Comparison of turbine-wheel cooling with short- and long-duration water sprays.

face of the turbine at the hub, the surface temperature dropped rapidly to the boiling temperature of water (curve A, fig. 18). Shortly after the water was expended, the surface of the wheel reheated by conduction from the hot interior. Unsafe temperatures above 600° F were established in less than 7 seconds. In order to avoid reheating to unsafe temperatures, the water discharge period was extended to 30 seconds. Experiments indicated that the quantity of water necessary could be reduced from 2 to 1 gallon for each face of the turbine disk. The wheel temperatures obtained are shown by curve B in figure 18. The time interval before reheating began was increased from 3 to 20 seconds. Reheating to temperatures above 600° F occurred after 27 seconds, at which time, however, the chance for fuel ingestion was remote.

This problem of reheating must always be considered in the use of water for cooling unsafe zones. The chance for fuel ingestion by the engine is greatest just before the airplane comes to rest in the first 5 seconds after crash impact. At this time fuel spilling from torn tanks has its broadest distribution forward of the wings in areas adjacent to the engines. Reheating after this time is not as serious within the engine as it would be on the outside surfaces which could be wetted by fuel that continues to drip and flow around the engine after the airplane comes to rest.

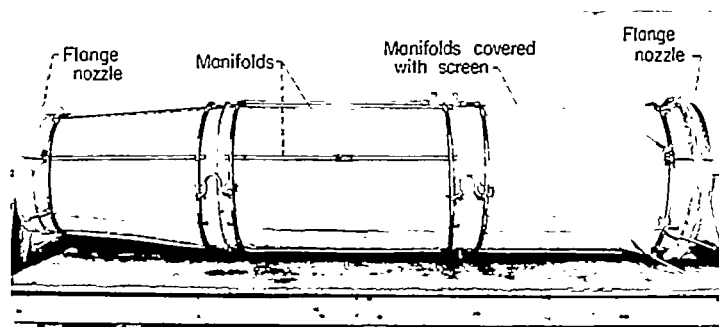
FIGURE 19.—Typical water distribution system for F-84 tailpipe.

Effective water distribution and wetting were promoted by wrapping a 100-mesh stainless-steel screen around the entire exhaust system. This screen was spotwelded to the tailcone and tailpipe. Water sprayed on the screen penetrated to the surface of the tailpipe and tailcone. The screen promoted wetting and discouraged the formation of rivulets.

Water distribution over the screen-covered exhaust system was provided by a network of flattened tubes mounted axially in contact with the screen. Water sprayed through orifices drilled into the flattened side of the manifold facing the tailcone and tailpipe. The discharge orifices were 0.040 inch in diameter and spaced so that each would distribute water over approximately 50 square inches. Additional holes were drilled where experiment showed them to be necessary to provide uniform wetting. The tubes were also covered with ribbons of stainless-steel screen and spaced around the tailcone and tailpipe in order to provide a uniform water distribution. Three circular water manifolds connected the tubes to form a single interconnected unit. This water system is shown partially installed on the J35 tailpipe in figure 19. Some of the flattened manifolds, which are uncovered,

are visible. The waffled appearance of the screen was produced by two sets of mutually perpendicular grooves that were rolled into the screen. These grooves permitted the screen to be tightly wound to the tailpipe and yet allowed water to flow under the screen.

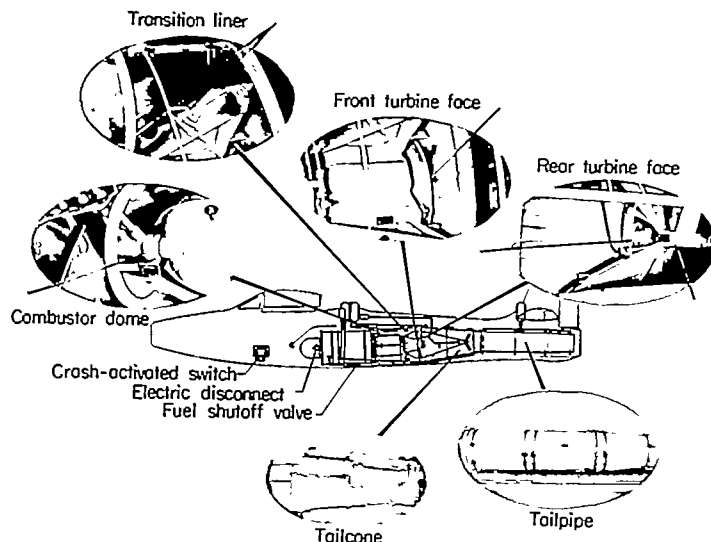
FIGURE 20.—Complete inerting system installed in F-84 airplane.

The complete crash-fire protection system used in this crash study is shown schematically in figure 20. The system comprised a water storage and distribution system, a shutoff valve for the combustor fuel, an electric switch for de-energizing the battery and generator circuits, and a crash-actuated switch for turning on the protection system. In these tests this switch was exposed on the airplane. The switch struck a target at the crash barrier which operated

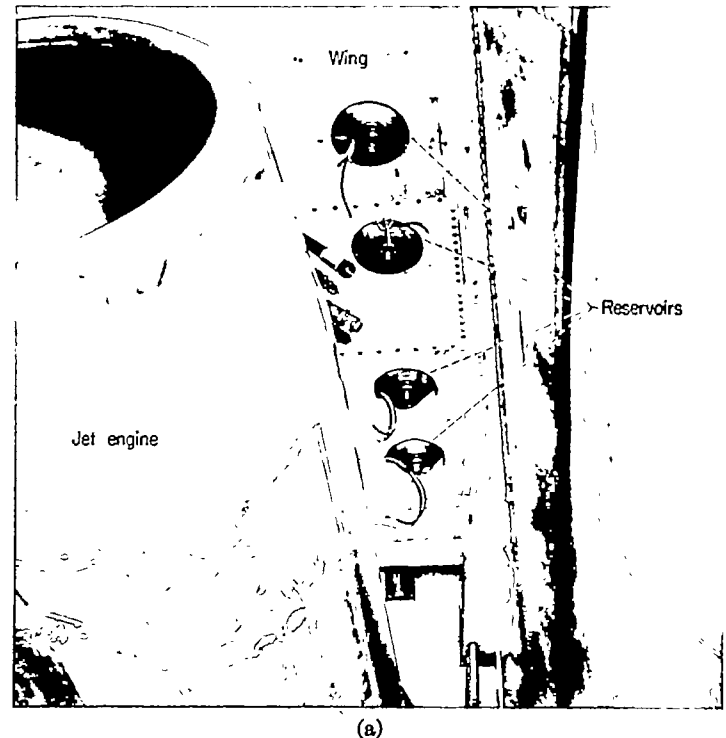
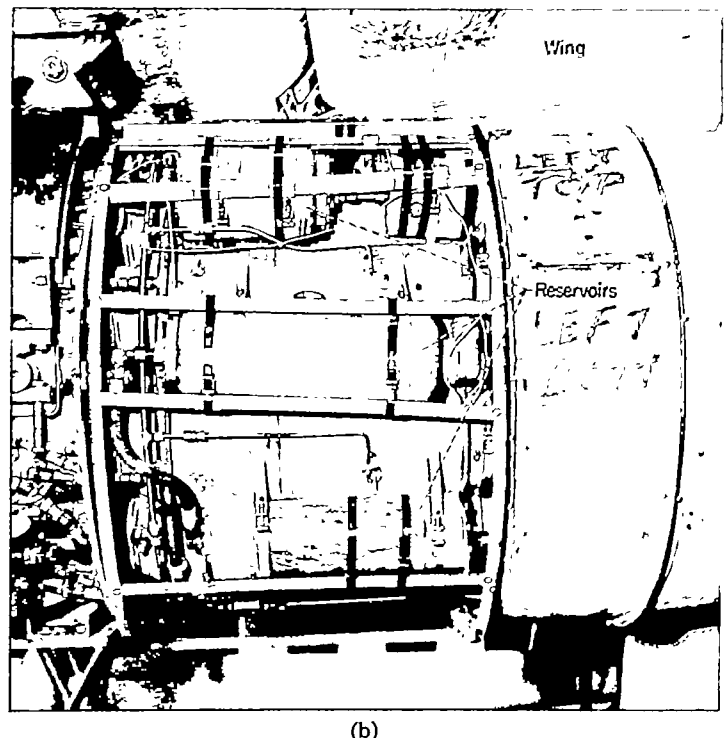
FIGURE 21.—Water reservoirs.

In three of the crashes of cargo airplanes fitted with J47 engines, the water reservoirs were carried in the wing root as shown in figure 21(a). Flexible lines joined these reservoirs to the engines. In one crash in which arrangements were made to rip the engine from the wing, the water reservoirs were strapped between the engine combustors as shown in figure 21(b).

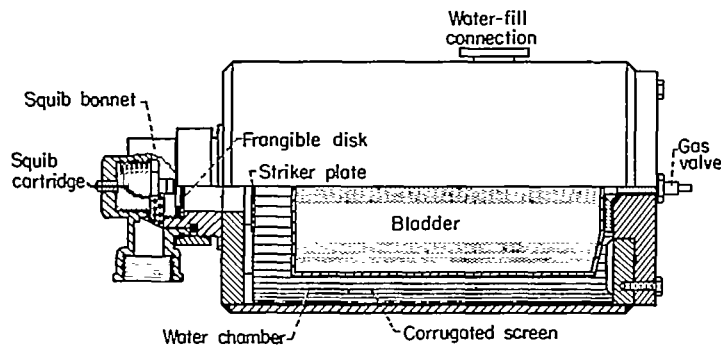
FIGURE 23.—Bladder-type water reservoir.

neoprene-fabric bladder insert. Water was retained in the steel cylinder while the volume of the bladder was filled with nitrogen gas at a pressure necessary to give the desired water discharge rate. When the outlet valve was opened, the bladder expanded, forcing the water to flow.

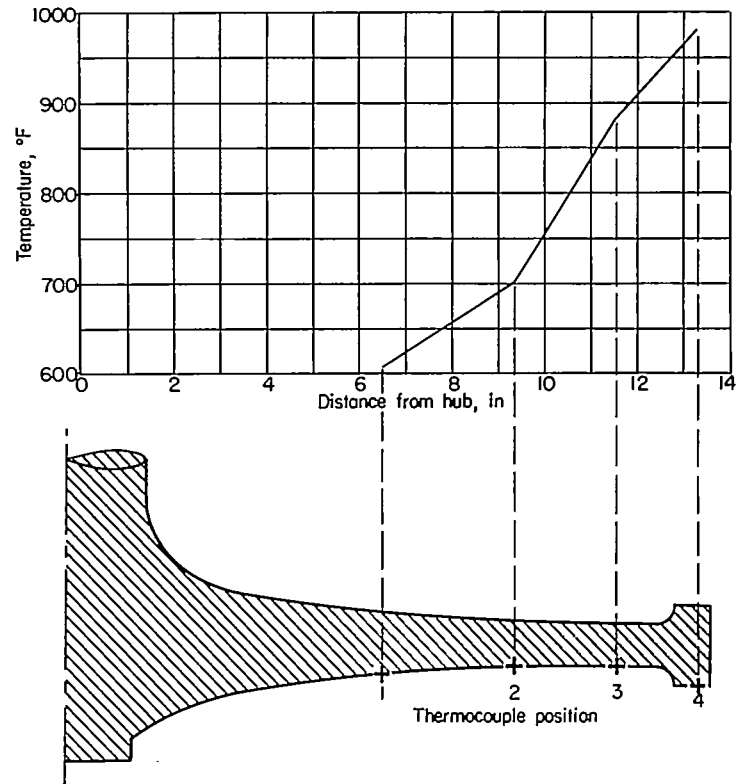
Engine parts not in the main gas stream were heated mostly by conduction. The turbine wheel was the most massive engine part heated this way. The radial variation in temperature on the surface of the turbine wheel, shown in figure 28, resulted from the fact that the heat conduction was from the wheel rim to the relatively cool hub. The data shown were obtained with the engine operating at rated sea-level conditions. The turbine-wheel surface temperature varied from approximately 980° F at the rim to about 605° F at a point midway between the rim and hub. Cooling air from the compressor applied to the hub to protect the engine bearings maintained this temperature pattern.

FIGURE 28.—Maximum temperatures recorded on J47-engine turbine wheel.

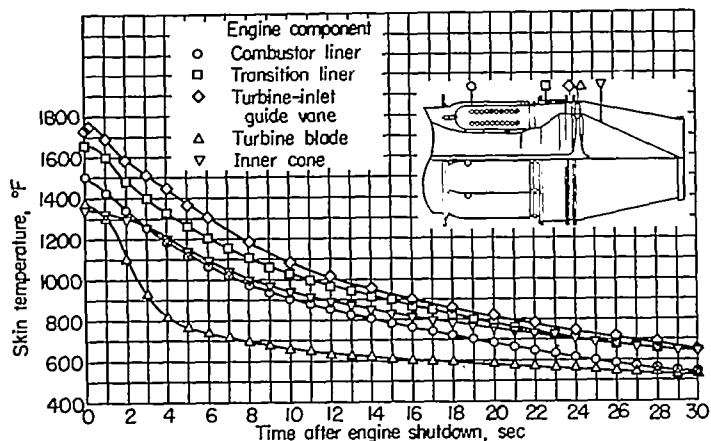
A history of the temperature of engine parts lying in the main gas stream is shown in figure 29. Fuel shutoff occurred at zero second, and the temperatures indicated were the maximum recorded anywhere on the component at the time noted. The hottest section of the combustion-chamber liner cooled from 1500° to 600° F in 24½ seconds. It took over 30 seconds for the transition-liner temperature to decline from 1660° to 600° F. In 30 seconds the turbine-inlet guide vane temperature dropped from a maximum temperature of 1750° to 645° F. The rotating turbine blade temperature fell from 1370° to 600° F in 16 seconds. Inner-cone skin temperatures declined from 1350° to 640° F in 30 seconds.

FIGURE 29.—History of maximum skin temperatures on engine components in main gas streams.

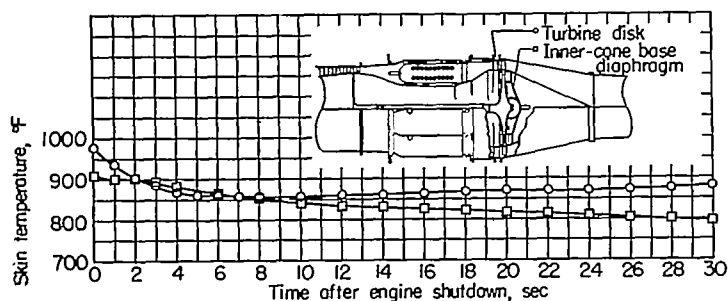
Engine parts not located in the main gas stream declined in temperature at much slower rates (fig. 30). The hottest part of the turbine wheel was initially at 980° F and dropped only 100° F in 30 seconds after fuel flow to the engine had stopped. The turbine wheel remained above the ignition

FIGURE 30.—History of maximum skin temperatures on turbine disk and inner-cone base diaphragm.

temperature of JP-4 fuel for 30 minutes after the engine was shut down. The large mass of the turbine disk contributed to its slow cooling rate. The inner-cone base diaphragm exhibited the same slow rate of cooling. Its maximum temperature was 910° F and cooled only approximately 115° F in 30 seconds.

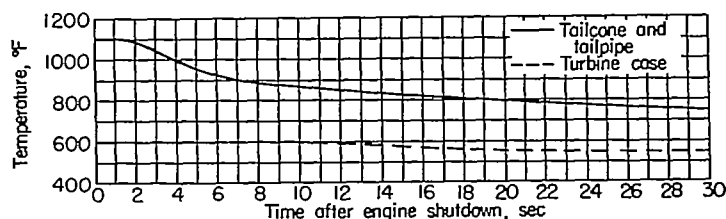
Temperature measurements made on the external skin of the J47 engine (fig. 31) indicated that the tailcone and tailpipe temperatures remained above 600° F for more than 30 seconds after the fuel to the combustor was shut off. Temperatures of the engine case upstream of the tailcone and tailpipe were usually below 600° F (fig. 32). Although the turbine case reached a maximum temperature of 600° F and remained so for 10 seconds after the fuel was shut off (fig. 31), no ignitions were experienced here.

FIGURE 31.—History of maximum external skin temperatures on J47 turbine case and tailcone and tailpipe.

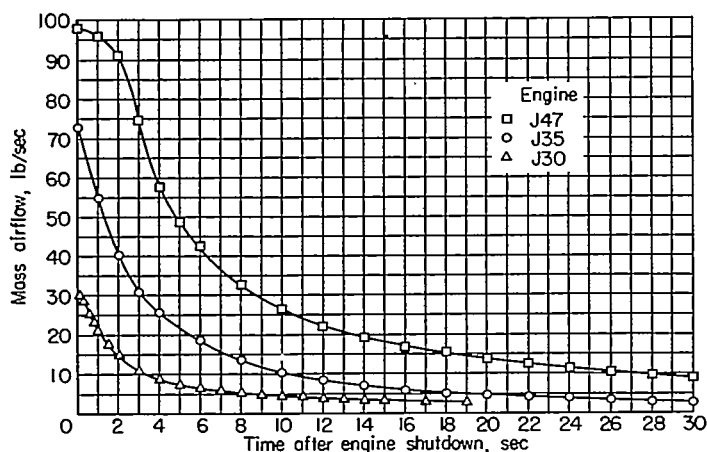
FIGURE 33.—Mass airflow after combustor fuel has been stopped.

The data on contact time required for ignition (fig. 8) can be used to obtain an approximation of the probability of hot-metal ignition of combustibles sucked into the engine inlet. The engine metal temperatures are known from the measurements given in figures 29 and 30. The contact time can be computed from the known mass airflow through the engine (fig. 33). From the airflow data for the J35

engine and the engine geometry, the local air velocity through the engine upstream of the turbine inlet was plotted and appears in figure 9. Velocities were calculated only at the engine stations marked on the sketch. Each line connecting the symbols provides the velocity distribution through the

engine at the time indicated. It is interesting to note that at 3 seconds after fuel shutoff the velocity at the compressor exit was slightly higher than at the compressor inlet. This was due to the fact that the turbine-inlet total temperature had fallen to the point where it caused a large drop in compressor-exit static pressure. The lower static pressure was the dominant influence on the speedup in airflow.

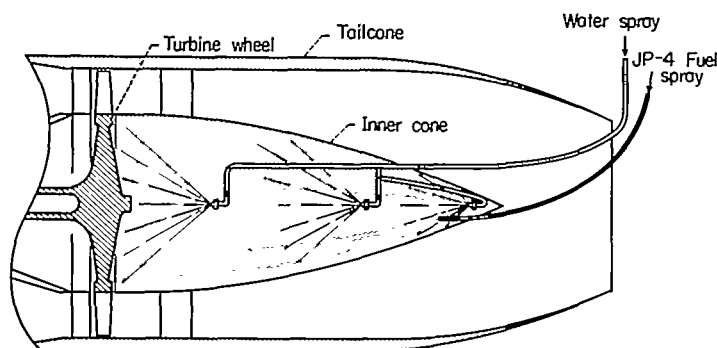
FIGURE 34.—Typical equipment used to study ignition hazard (J30 inner tailcone).

The engine cavity farthest downstream, the inner cone, was studied first. The arrangements used for the J30 tailcone are shown schematically in figure 34. A fuel system,

consisting of a single tube and nozzle, was arranged to spray fuel in measured quantities into the cavity of the inner cone to produce a combustible atmosphere. In addition, three water spray nozzles were installed facing the upstream direction. Since the J30 engine has no base diaphragm, the downstream face of the turbine wheel must be taken as a bounding surface of this cavity. The upstream water nozzle
